**END OF LUKONDE SOLAR POWERED WATER PROJECT REPORT
TO FAIR HANDELN**

Prepared by: Caritas Monze Team

January, 2022

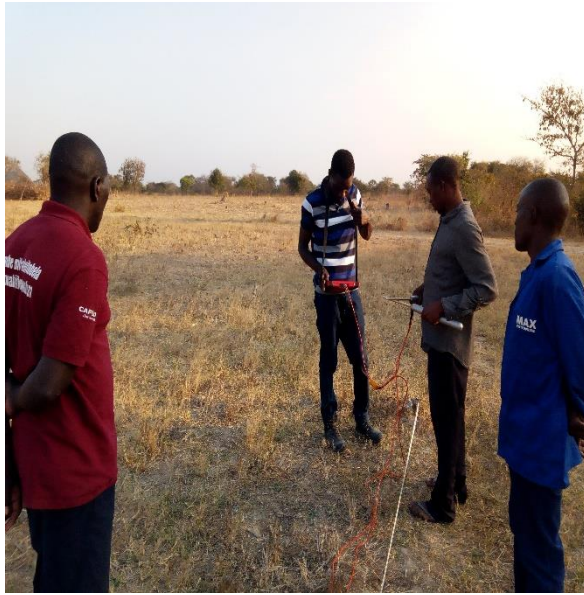
Figure 3 Geophysical Water Sitting

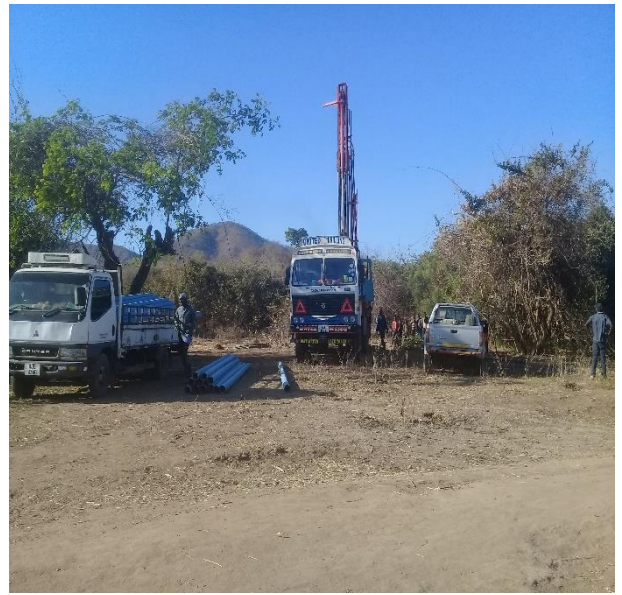
Figure 1 Drilling on the selected site

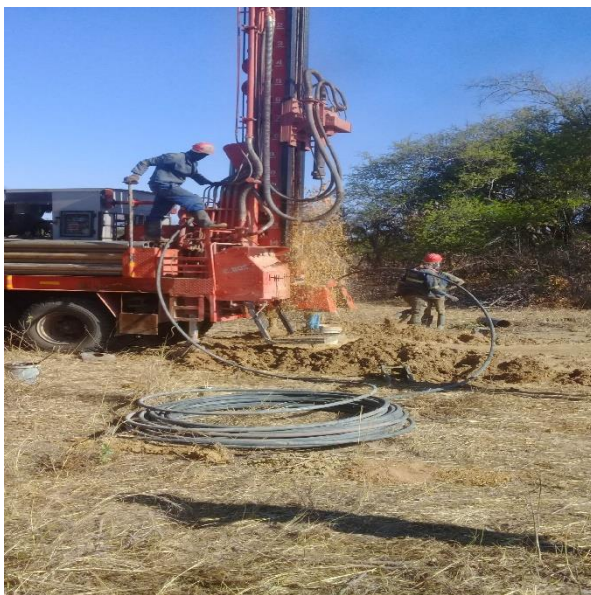
Figure 4 Borehole Drilling

The first 16 meters turned out that it was loose formation, therefore, 8 inch metal casings were put up to 18 meters and this resulted paying an extra amount of ZMW 25,056. Use of metal casings was necessary as the first 16 meters was loose formation and having such casings will enable community members derive maximum benefits for decades.

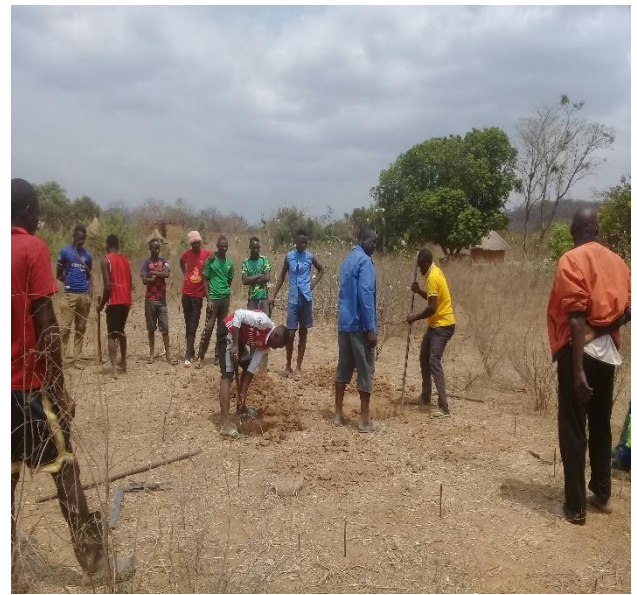
Figure 2 Digging a foundation for the Water Tank Stand

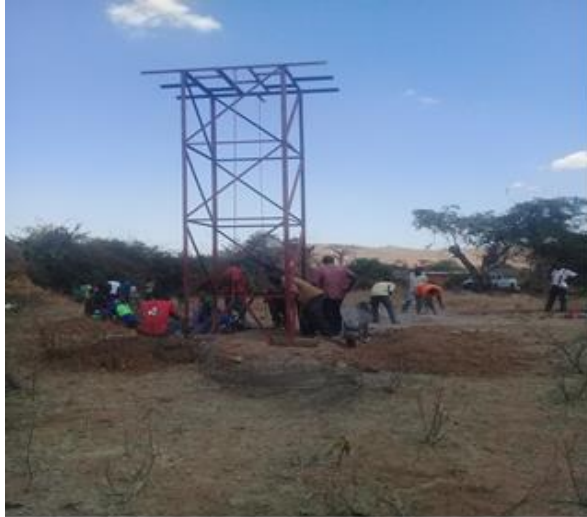
Figure 6 Erecting the water tank stand

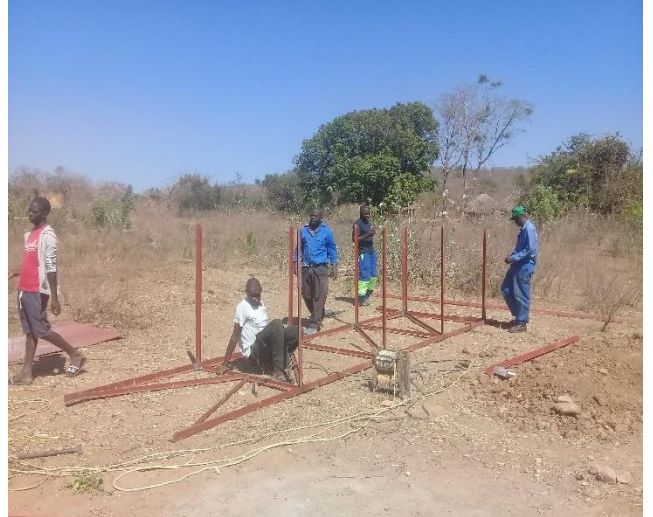
Figure 5 Fabrication of the 5 meter water tank stand

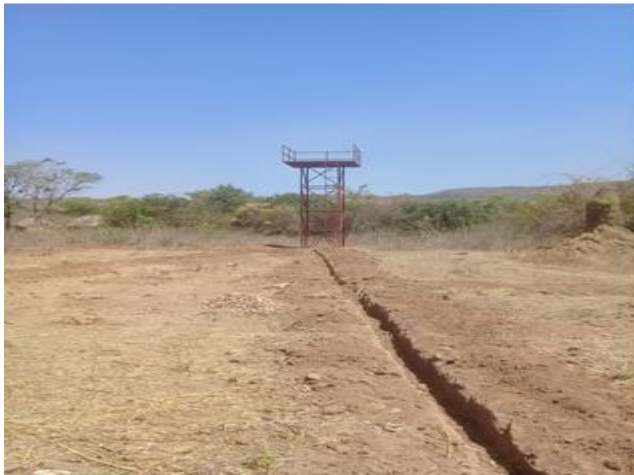
Figure 7 Preparing for laying of pipes

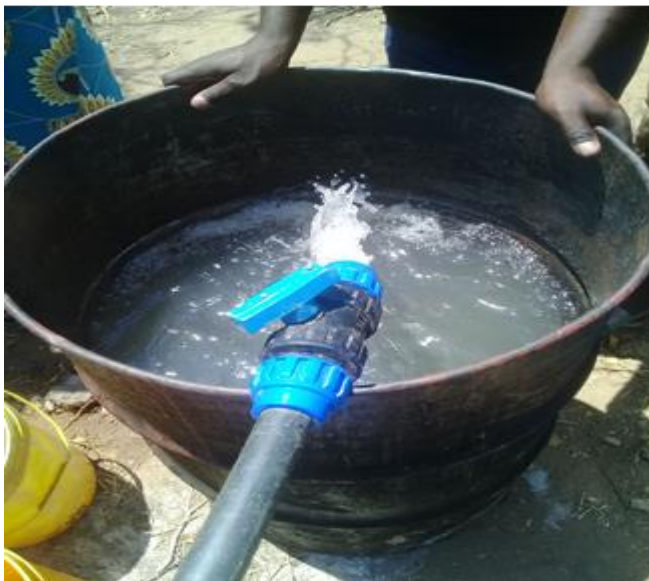
Figure 8 Pumping Test

The pumping test revealed that community members will greatly benefit from this water facility having recorded a yield of 1.53 litres per second during the pumping test.

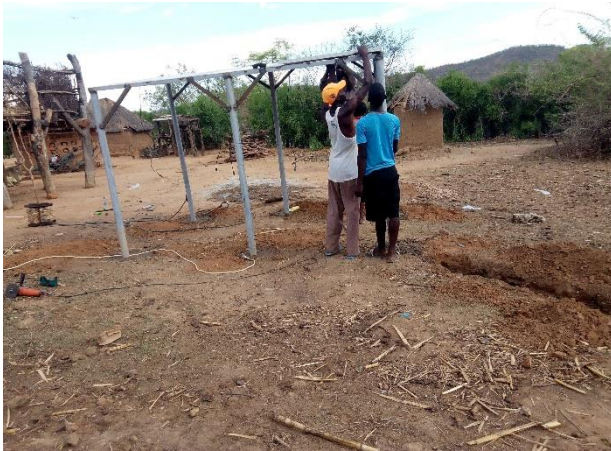
Figure 9 Solar panel fabrication

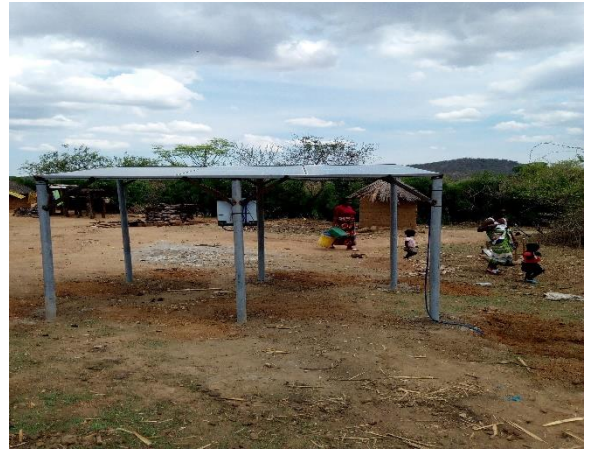
Figure 10 : 3 x 340 watts solar panels

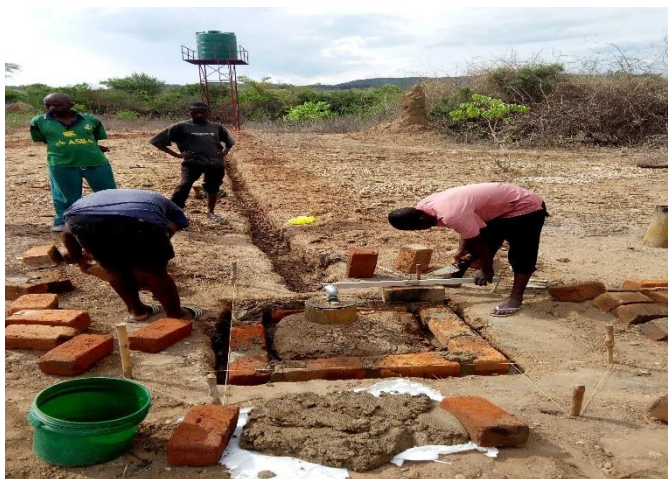
Figure 11 Pump house construction

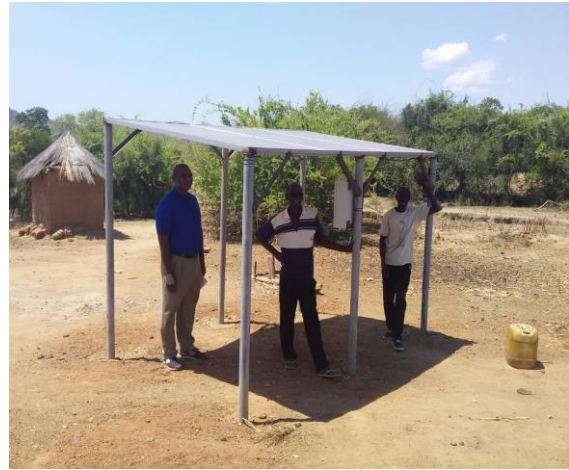
Figure 13: Mounted Solar panels

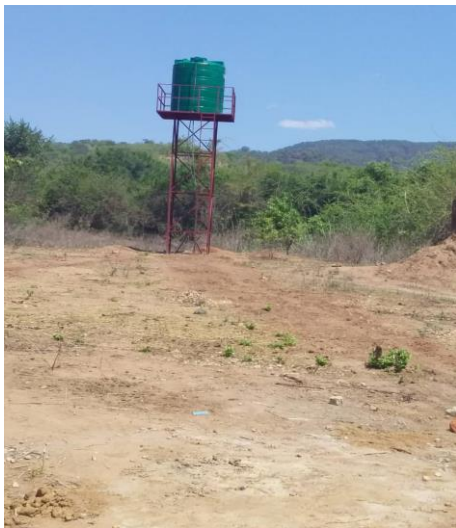
Figure 14: A 5000 ltrs tank mounted on a stand
